“Generator Field Winding Shorted Turns: Observed Conditions and Causes”

DJ Albright and DR Albright, Generatortech, Inc.

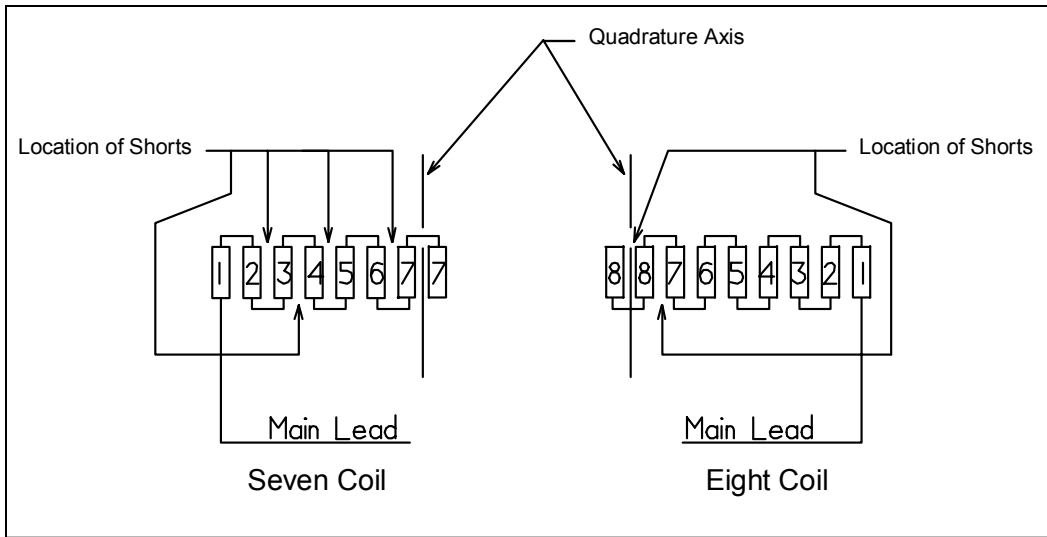
Figures 3, 4 and 5 relate to our observations of cases of coil-to-coil shorts. Figure 3 shows the locations that coil-to-coil shorts have been observed. Figure 4 is a sample of flux probe test data showing a coil-to-coil short. Figure 5 is a photo of a short between coils 6 and 7 of a seven-coil field.

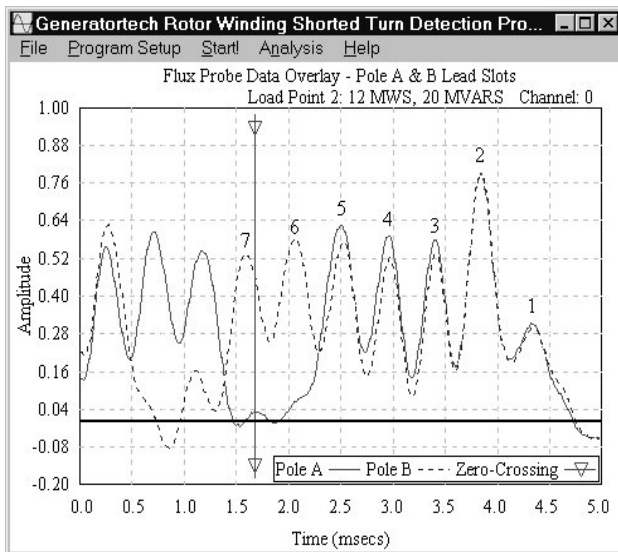
Figure 4 – Coil 6 and 7, Pole A shorted

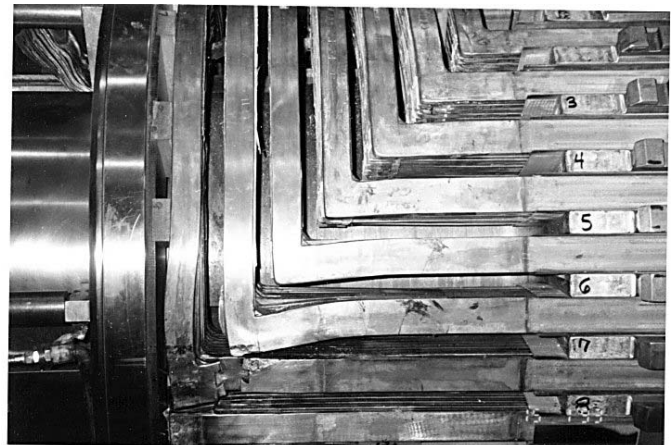
The most serious condition caused by shorted turns is arcing damage to the retaining ring. The cases we have observed are those where the top turn of one coil comes into contact with the top turn of an adjacent coil. The arcing from this contact will burn through the retaining ring insulation and cause a defect in the retaining ring itself. A structural defect in the retaining ring is a very serious condition requiring immediate shutdown due to the danger to plant personnel. This type of shorted turn condition will give either a momentary or sustained field ground indication. Once a ground indication is found, flux probe testing should be conducted to determine if shorted turns are present. Any flux probe test that shows that entire coils are out of the field circuit should lead to the suspicion that retaining ring damage may have occurred.

Figure 5-Elongated Coil 6 contacts Coil 7
