EPRI – Steam Turbine-Generatortech  
Workshop and Vendor Exposition  
August 25-27, 2003  
Nashville, TN

## **“Generator Field Winding Shorted Turns: Moisture Effects”**

JD Albright and DR Albright, Generatortech, Inc.

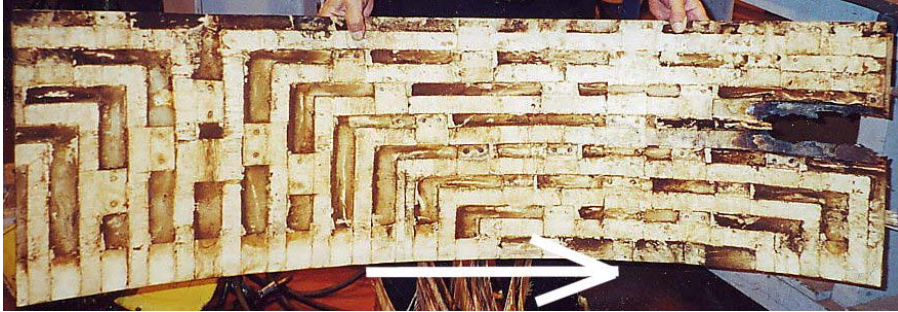
Contaminants are impinged on the inner retaining ring insulation surface due to centrifugal forces. Moisture, introduced to the cooling gas, by any number of ways, will be absorbed by the contaminants creating a conductive bridge between coils. Creepage paths in this location have caused coil-to-coil failures. (Fig. 2 and 3) On air-cooled generators, hand wrapping of the top one or two turns may aid in precluding this type of failure.

Figures 2 and 3 show the after effects of a Coil 4 to Coil 5 short to the retaining ring. Both coils were shorted out. Figure 2 is the inner layer of the ring insulation from an air-cooled generator. Similar conditions have been observed in hydrogen-cooled generators. The light colored areas are the outlines of the end windings and blocks. The dark areas are contaminants deposited by centrifuge action on the retaining ring insulation surface. Note the rotational direction arrow and note that the heaviest buildup of contamination is at the leading edge of the blocking. It has been our experience that coil-to-coil shorts due to contamination normally occur at the leading edges of the blocks.

Fig. 2 – Burned R.R. Insulation Contaminant Induced Coil-to-Coil Short

Fig. 3 – Blocking from Fig. 2 failure

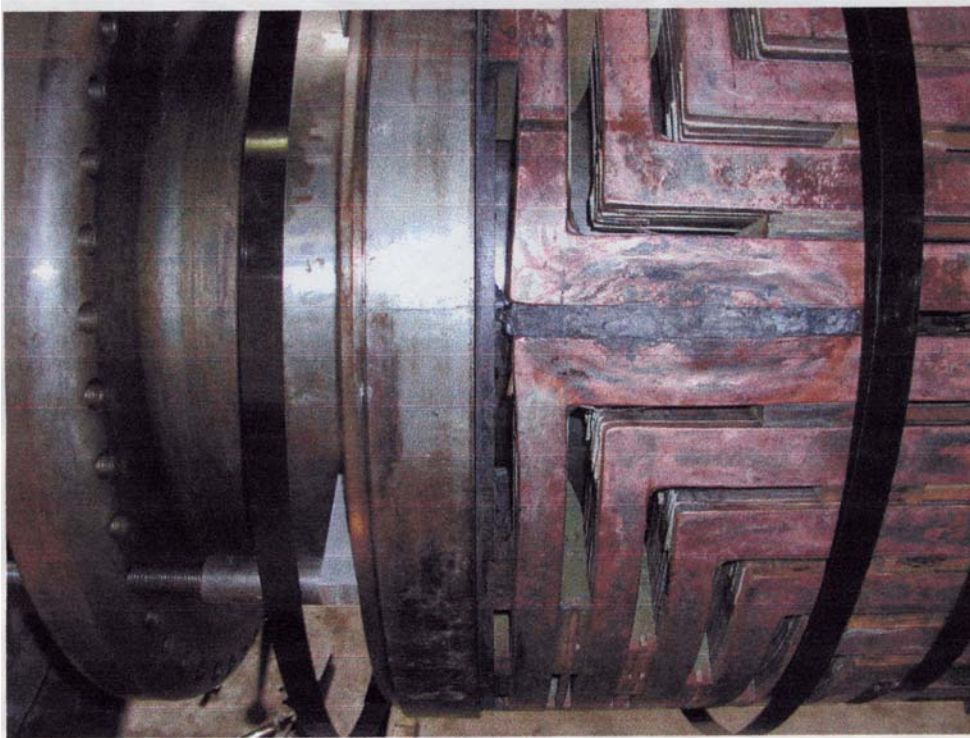
Figure 4 depicts another coil-to-coil short as viewed with the retaining ring and insulation removed. This condition had shorted both #8 coils out of the field circuit. This generator had operated for 14 years. Figure 5 is the same field as viewed from 180° from Figure 4. It is clear there is no distortion of the windings. Winding distortion is the most common cause of coil-to-coil shorts. It is therefore reasonable to assume that moisture and contamination that had centrifuged to the retaining ring insulation and created a low resistance creepage path causing the failure.

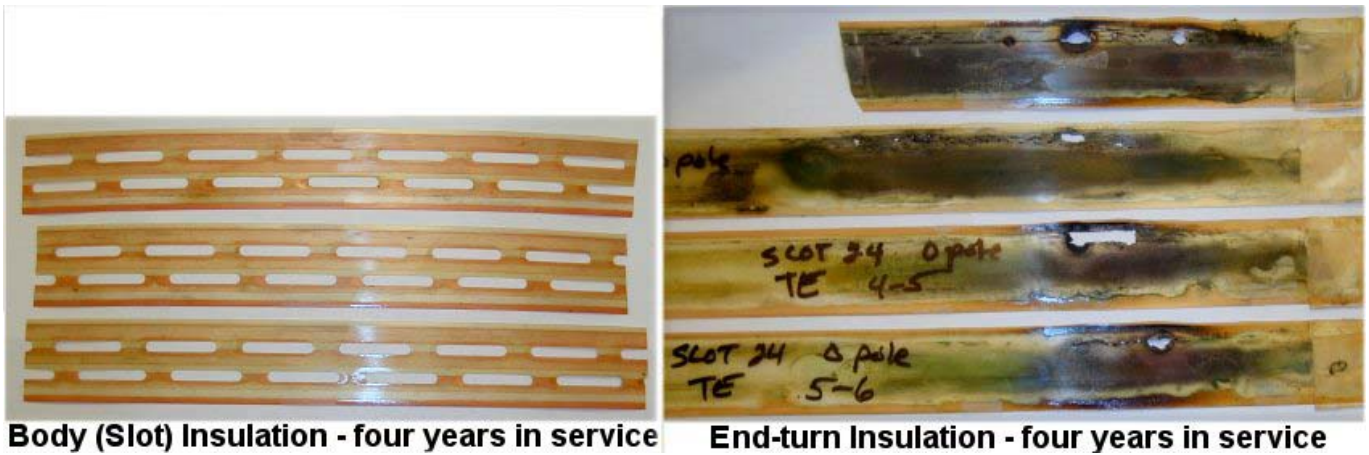
During the rewind of this field, we were able to compare samples of the body insulation to the end-winding insulation. The body copper insulation showed no deterioration whereas the end turn insulation showed significant amounts of deterioration. Deterioration was in the form of color changes (green, red and blue), cracks and carbonization of the glass fibers. Figure 6 shows a comparison of the body and end turn insulation samples from the same generator.

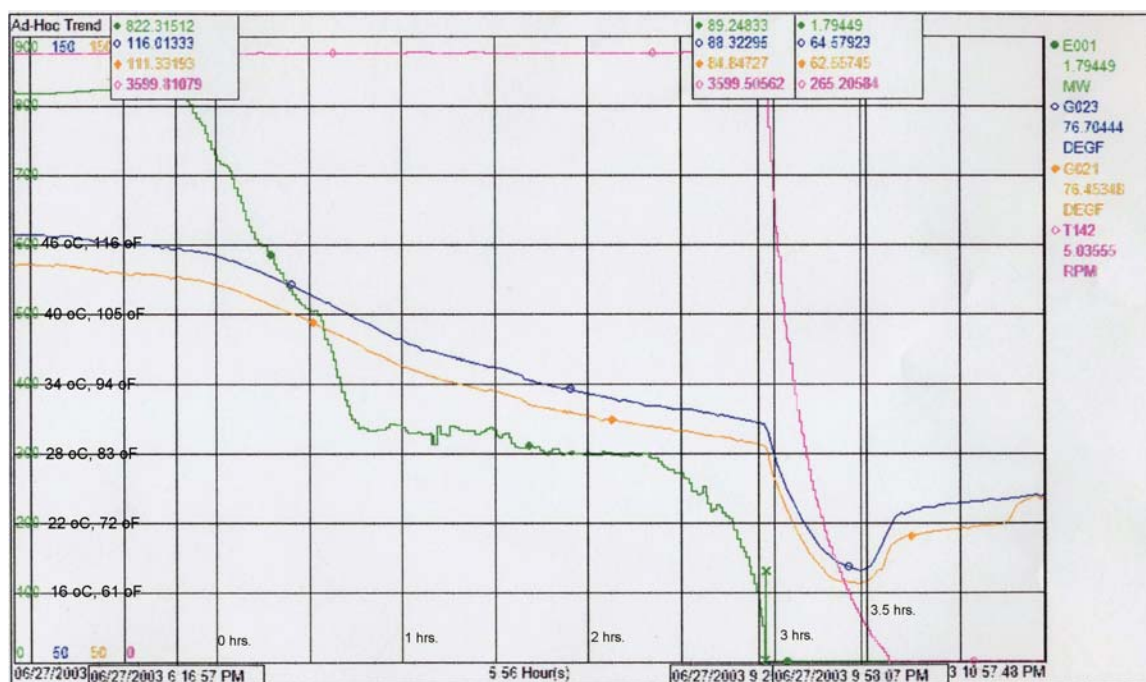
Figure 7 depicts a typical shutdown of a generator. Megawatt load, turbine end and exciter end cold gas temperatures and rotor speed are plotted. It can be seen that the cold gas temperature drops rapidly after the generator is tripped. Figure 7 is a summer shutdown curve. Winter shutdowns generally will result in lower temperatures due to lower cooling water temperatures. The end turn area, being the first to see cold gas and lacking any significant mass to help maintain heat, rapidly approaches cold gas temperature.

What one should recognize from a review of this curve, is that cooling gas dew points must be maintained safely below cold gas temperatures achieved on shutdown. Dew points above the shutdown cooling gas temperature will result in moisture collecting under the retaining rings and significantly increase the risk of shorted turn development in the end turn region.

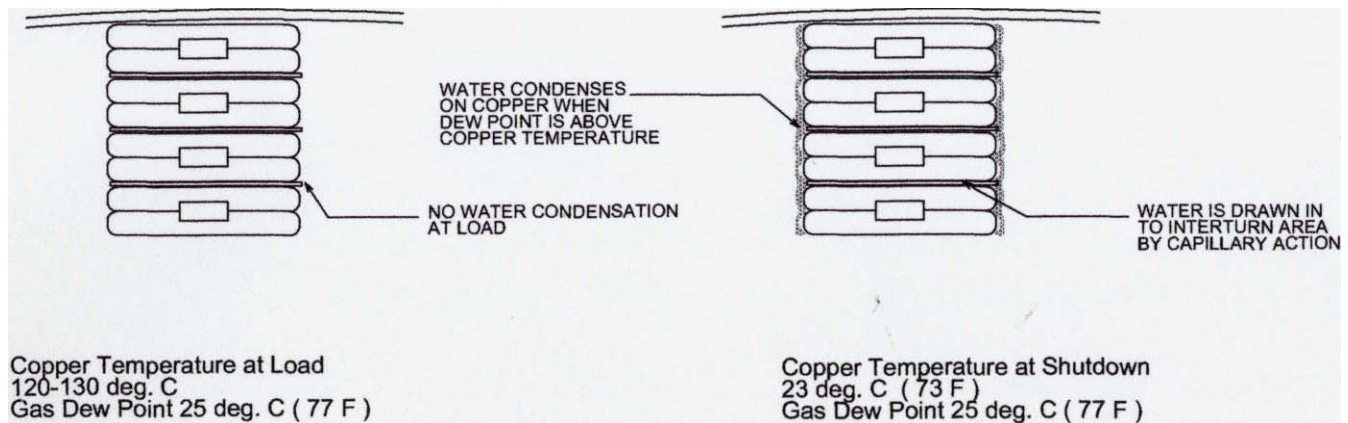
If the hydrogen gas dew point is higher than the end winding copper temperature, moisture will condense on the end windings and be drawn into the crevices by capillary action and start to attack the polyester resin. (Fig. 8)

**Figure 8 – Condensation of Water on End Windings due to High Dew Point of Cooling Gas**

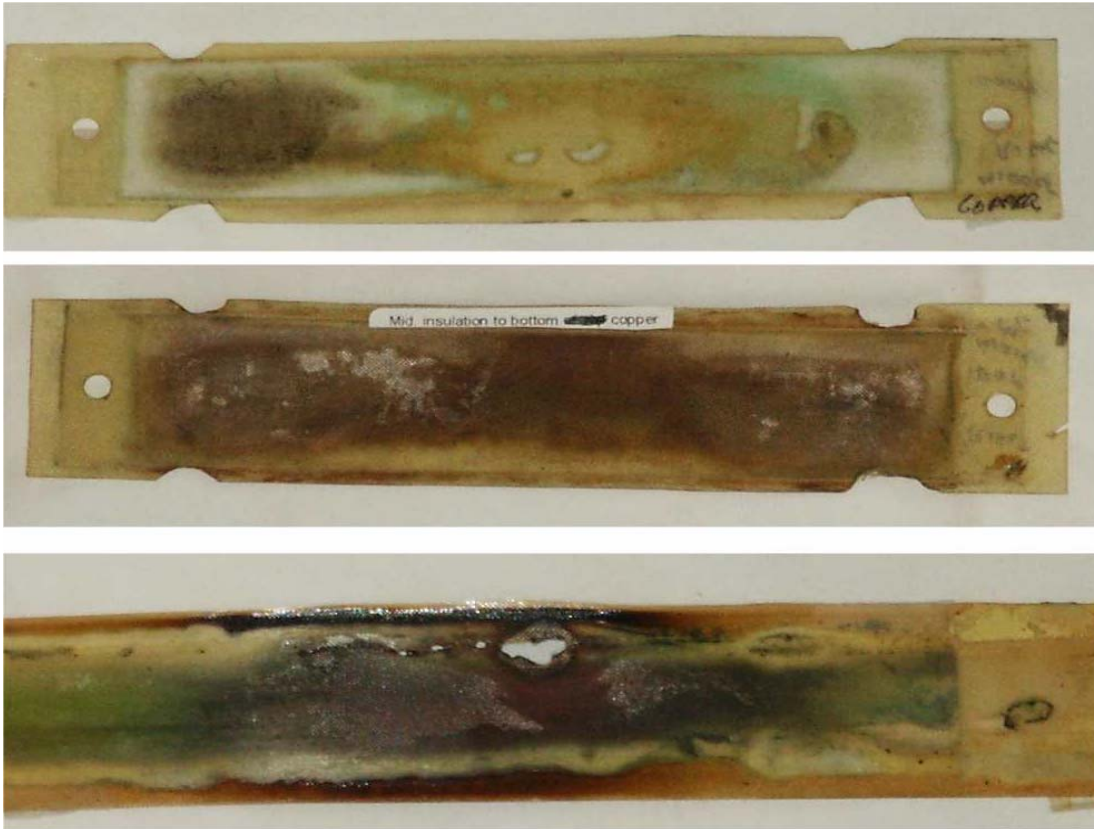
Figure 9 shows the test samples. The sample in the center of the figure is the moistened sample. Above it, is the sample from the dry test. The lower sample is a piece of turn insulation from a generator that had experienced many shorts in the end turn region.

The results of the testing confirm to a high degree that moisture contributes significantly to the breakdown of the interturn insulation.
