INTERTURN SHORT-CIRCUIT DETECTOR FOR TURBINE-GENERATOR ROTOR WINDINGS

D. R. Albright
Generator Department
General Electric Company
Schenectady, New York

Presented at the
**INSTITUTE OF ELECTRICAL AND ELECTRONICS ENGINEERS
SUMMER POWER MEETING AND EHV CONFERENCE**

Los Angeles, California
July 12-17, 1970

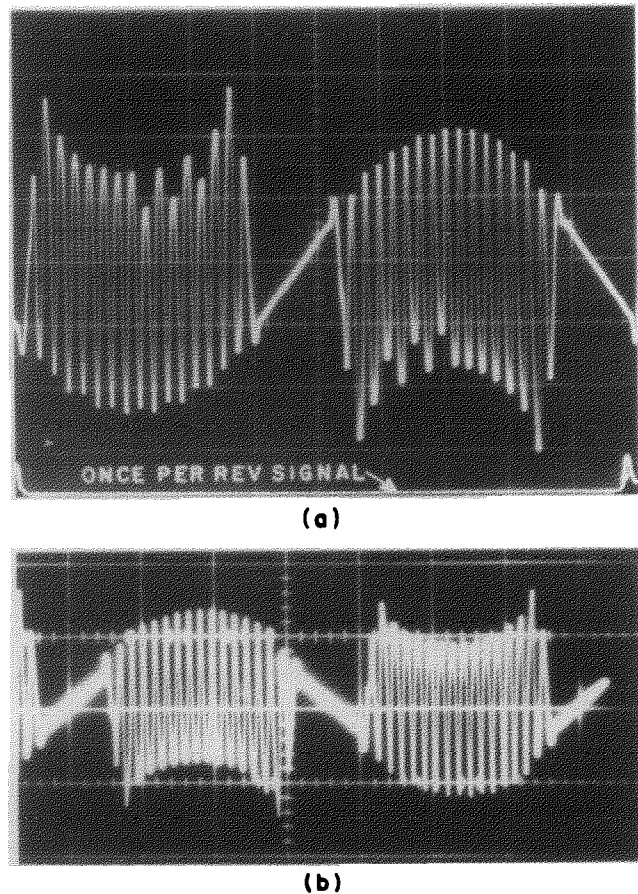
Fig. 6. Short-circuit radial flux coil wave shapes obtained during a rotor vibration problem investigation. (a) Data obtained before the repair. (b) Data obtained after the repair

This detector was used on four generators where thermal balance problems were considered excessive. In all cases, the results indicated shorted turns could be the major reason for the thermal sensitive conditions as the shorted turns were located asymmetrically within the rotor. Figure 6 shows the results obtained before and after the repair on one unit. In two of the cases, where corrective action was taken, significant improvements in performance were observed. In one case, where only one shorted turn existed before taking corrective action, an improvement was observed, but conditions other than the shorted turns proved to be causing part of the thermal sensitive condition. In the fourth case, no corrective action was taken as the estimated cost to make the repair was considered too high for the anticipated gain in performance.

be obtained. This signal, super-imposed on the search coil wave picture, will identify the pole numbers and the slot numbers. A dual trace oscilloscope is particularly adaptable for this application (see Fig. 6(a)).
