BY DONALD R. ALBRIGHT, DAVID J. ALBRIGHT AND  
JAMES D. ALBRIGHT, GENERATORTECH, INC.

# FLUX PROBES PROVIDE ON-LINE DETECTION OF GENERATOR SHORTED TURNS

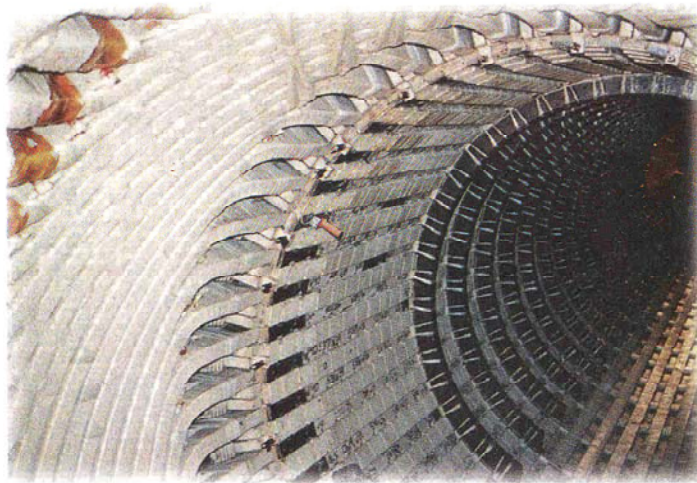
Typical air-gap flux probe installation.

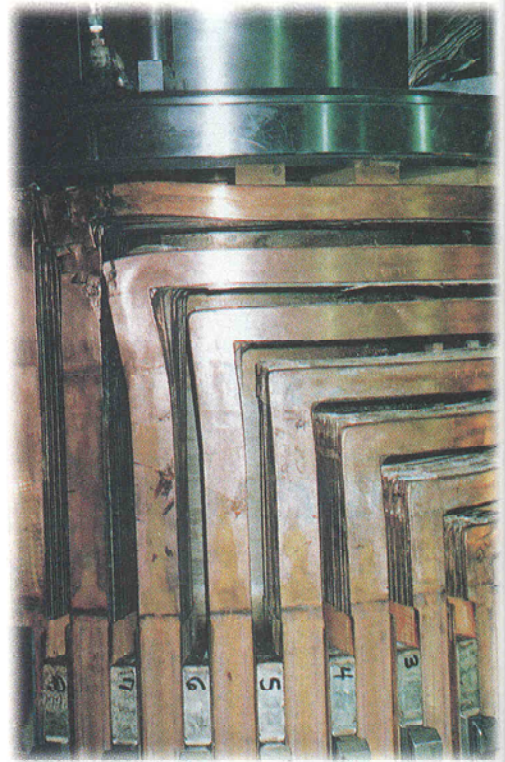
Top turn of No. 7 coil shorted to top turn of No. 8 coil.

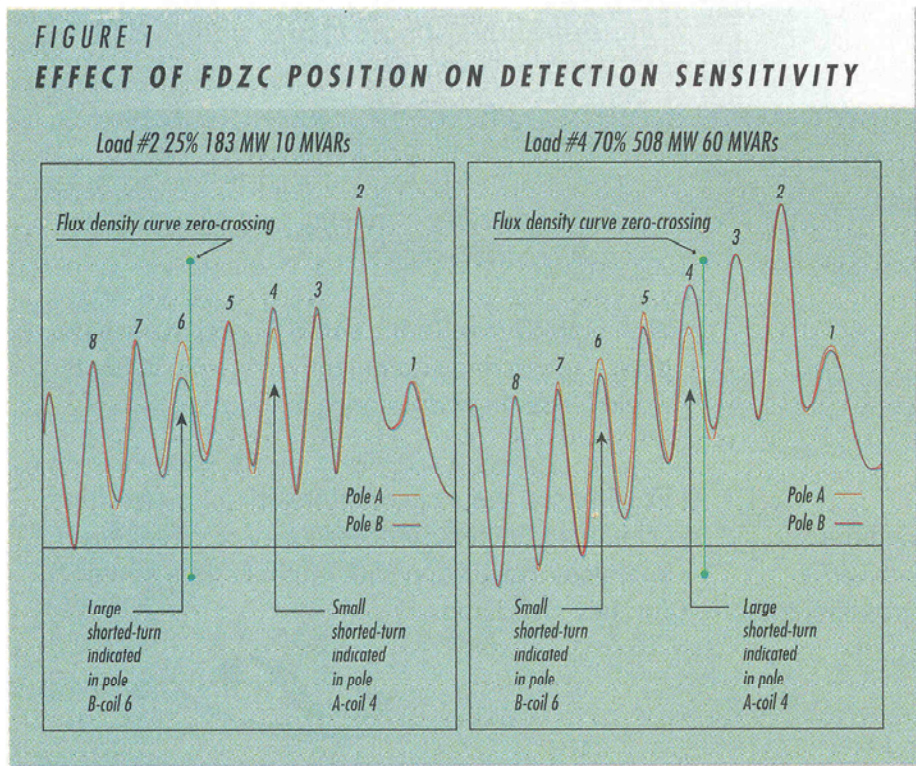
The first case study illustrates the effects of the FDZC on shorted turn detection sensitivity. Figure 1 displays two lead slot overlay graphs for a two-pole rotor with one shorted turn in both

Pole A-Coil 4 and Pole B-Coil 6. The left graph is at 25 percent of full load and has a FDZC position near the lead slot of coil 6. The left graph shows a significant shorted turn indication for Pole B-Coil 6, while the shorted turn indication for Pole A-Coil 4 is quite small. The right graph is at 70 percent of full load and has a FDZC position near the lead slot of coil

4. In this graph, the Pole B-Coil 6 indication has been reduced, while the Pole A-Coil 4 indication has been magnified. This example emphasizes the importance of recording a series of load points from zero to full load. It has

The waveforms displayed in Figure 1 also show the effect of the use of magnetic rotor wedges. (Magnetic rotor wedges can significantly reduce flux probe sensitivity by shunting the slot leakage flux through the magnetic wedge.) The No. 1 coil slots made use of magnetic wedges in this rotor. As can be seen in the graph, the No. 1 coil peaks are much reduced in amplitude relative to the other coil slot peaks.

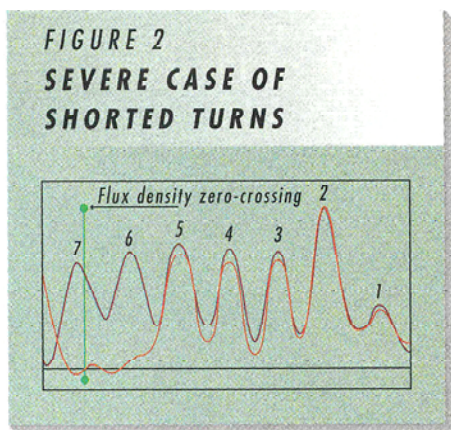
The second case study presents a two-pole rotor with seven coils/pole in which coils 6 and 7 of one pole were shorted out of the field circuit. This occurred when the top turns of coils 6 and 7 on one pole became shorted together. Figure 2 displays this particularly severe case of shorted turns. The figure displays a dramatic absence of signal for the lead slots of coils 6 and 7 of one pole. The unit was only able to run at reduced loads due to excitation limits.

Thermal sensitive balance problems were minimized because the location of the slots for coils 6 and 7 are nearly 180 degrees apart and because the unit was running at reduced field excitation.
